## Massey Ferguson MF 7318 2024

Serial Number **7318698241**

Inspection date **16 May 2026**

Address of the  
inspection **Aparecida de  
Goiânia**

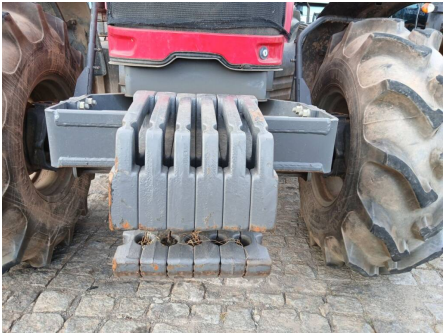
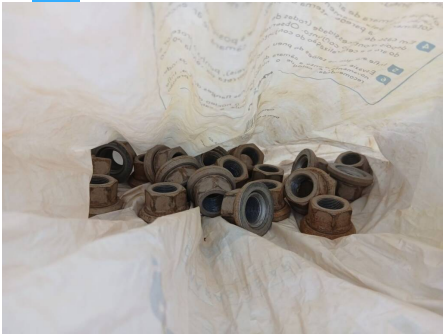
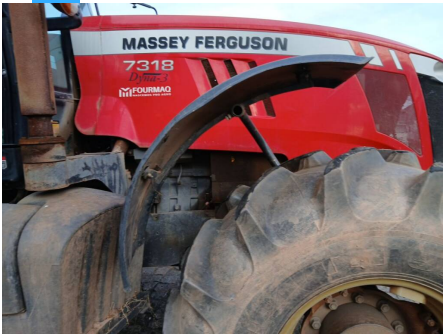
53

| Value | Note | |
|---|---|---|
| Breakdowns (more than 1 if necessary) | EQUIPAMENTO COM RISCOS NA PINTURA/ MAL-FUNCIONAMENTO PONTOS DE FERUGENS NOS PESOS DIANTEIRO / POSSUE PNEUS FILIPADOS FALTA ANTENA GPS/ MONITOR REGULAR FECHADURA DO CAPÔ AVARIADA/ BETERIA RUIM | 51, 52, 53, 54, 55, 56, 57, 58, 59, 60, 61, 62, 63 |
