## Massey Ferguson MF 7318 2024

Serial Number **7318698241**

Inspection date **16 May 2026**

Address of the  
inspection **Aparecida de  
Goiânia**

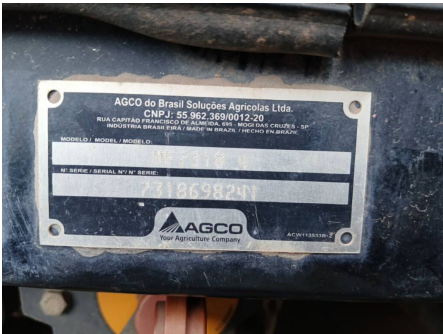
1

Serial No

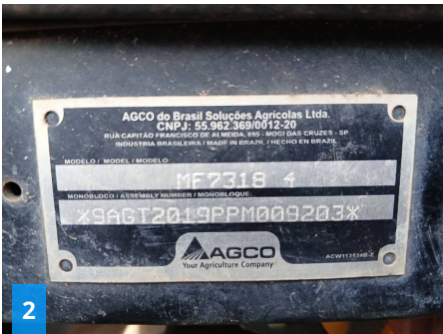
2

Chassis no

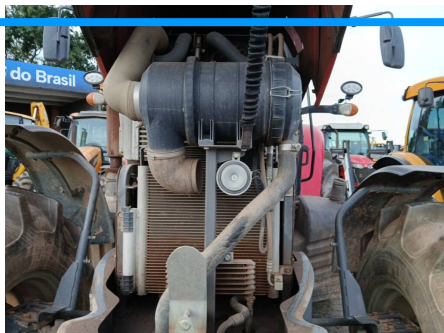
12

| | Value | Note | |
|---|---|---|---|
| Radiator | | | 12, 13 |

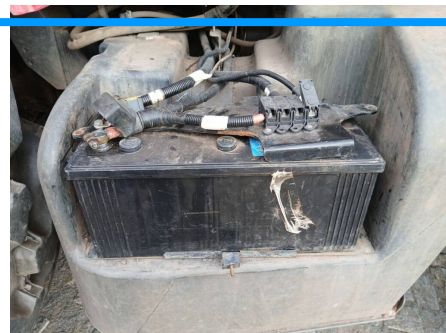
| | Value | Note | |
|---|---|---|---|
| Battery photo | | | 14 |

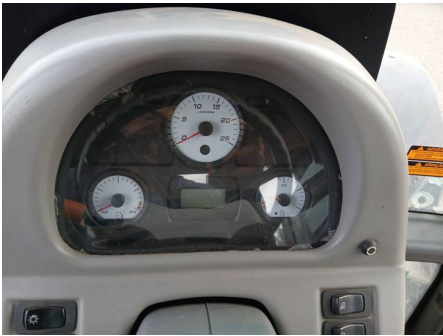
15

| | Value | Note | |
|---|---|---|---|
| Hours | | | 15, 16 |

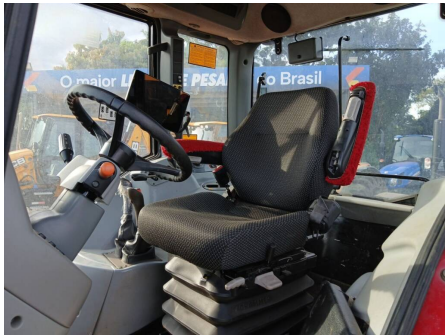
17

| | Value | Note | |
|---|---|---|---|
| Seat | | | 17, 18 |

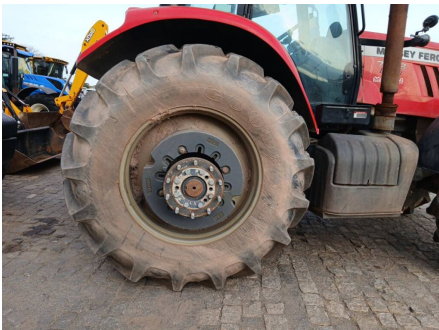
| | Value | Note | |
|---|---|---|---|
| Right Back Tyre | | | 38 |
| Right Back Tyre Condition | Regular | | |

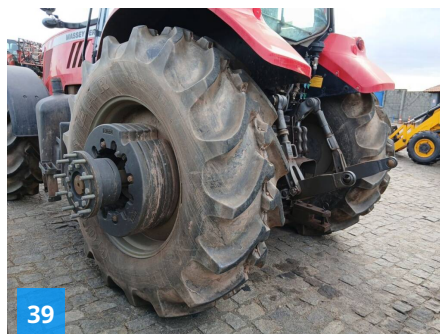
| | Value | Note | |
|---|---|---|---|
| Tyre image | | | 39 |

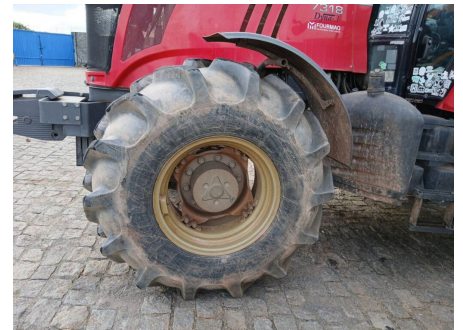
| | Value | Note | |
|---|---|---|---|
| Left Front Tyre | | | 40 |
| Left Front Tyre Condition | Regular | | |

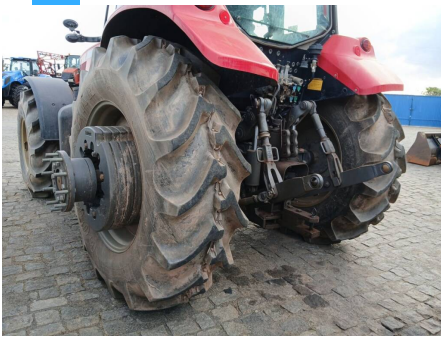
| | Value | Note | |
|---|---|---|---|
| Tyre Tread Left Back | | | 44 |

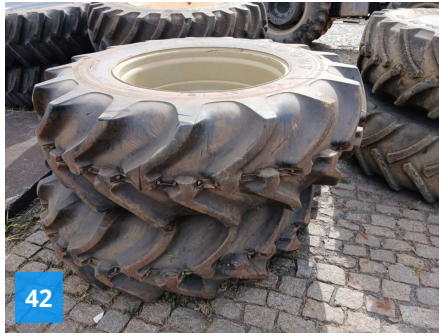
| | Value | Note | |
|---|---|---|---|
| Double Wheel | | SIM | 42 |

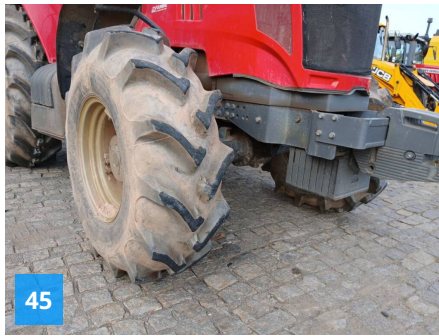
| | Value | Note | |
|---|---|---|---|
| Tyre Tread Right Front | | | 45 |

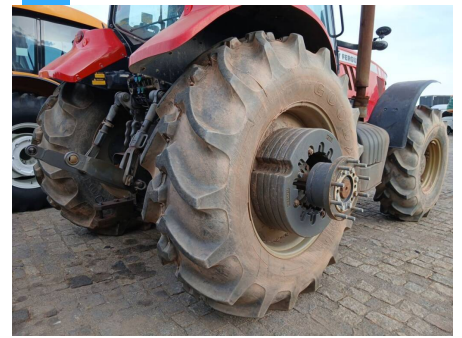
| | Value | Note | |
|---|---|---|---|
| Tyre Tread Right Back | | | 46 |

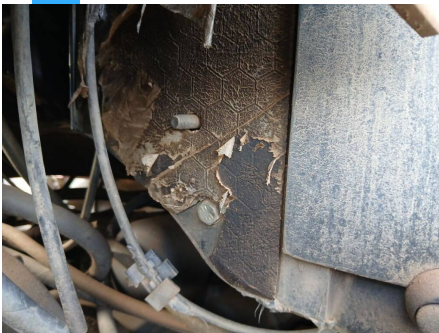
62

| Value | Note | |
|---|---|---|
| Breakdowns (more than 1 if necessary) | EQUIPAMENTO COM RISCOS NA PINTURA/ MAL-FUNCIONAMENTO PONTOS DE FERUGENS NOS PESOS DIANTEIRO / POSSUE PNEUS FILIPADOS FALTA ANTENA GPS/ MONITOR REGULAR FECHADURA DO CAPÔ AVARIADA/ BETERIA RUIM | 51, 52, 53, 54, 55, 56, 57, 58, 59, 60, 61, 62, 63 |
